VALVES AND VALVE PROBLEMS

MR. A. PERKINS (MSFC)

FACILITY FORM 602
N 67-19032
(ACCESSION NUMBER)
39
(PAGES)
TM-X-59419
(NASA CR OR TMX OR AD NUMBER)

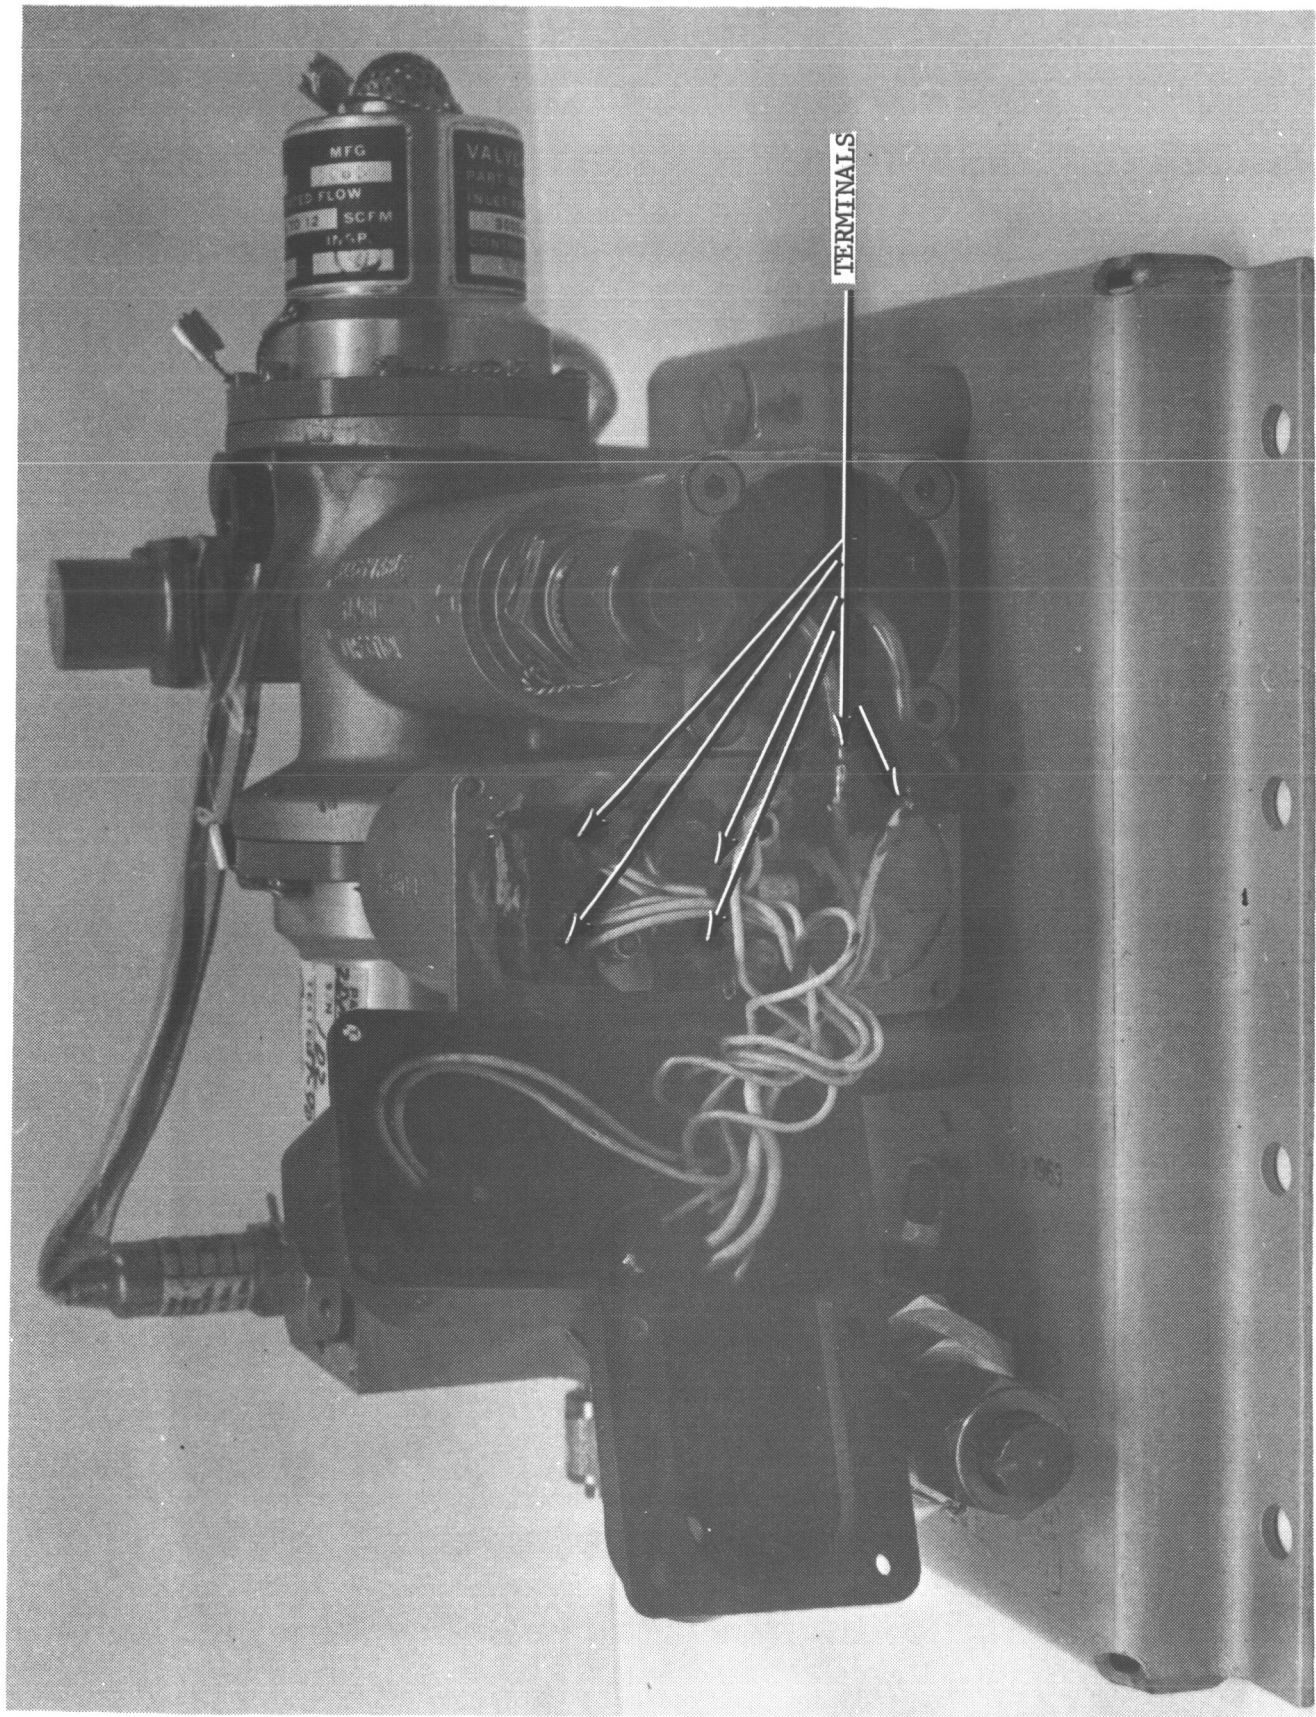
Figure 6 shows the electrical terminals in the regulation system. The insulation resistance broke down when the temperature of the regulator was elevated. The cause of this problem was found to be defective electrical insulator terminals which were replaced with terminals known to withstand the required temperature.

FIGURE 6. ELECTRICAL TERMINALS OF BLOCK II SATURN GAS BEARING SUPPLY REGULATION SYSTEM

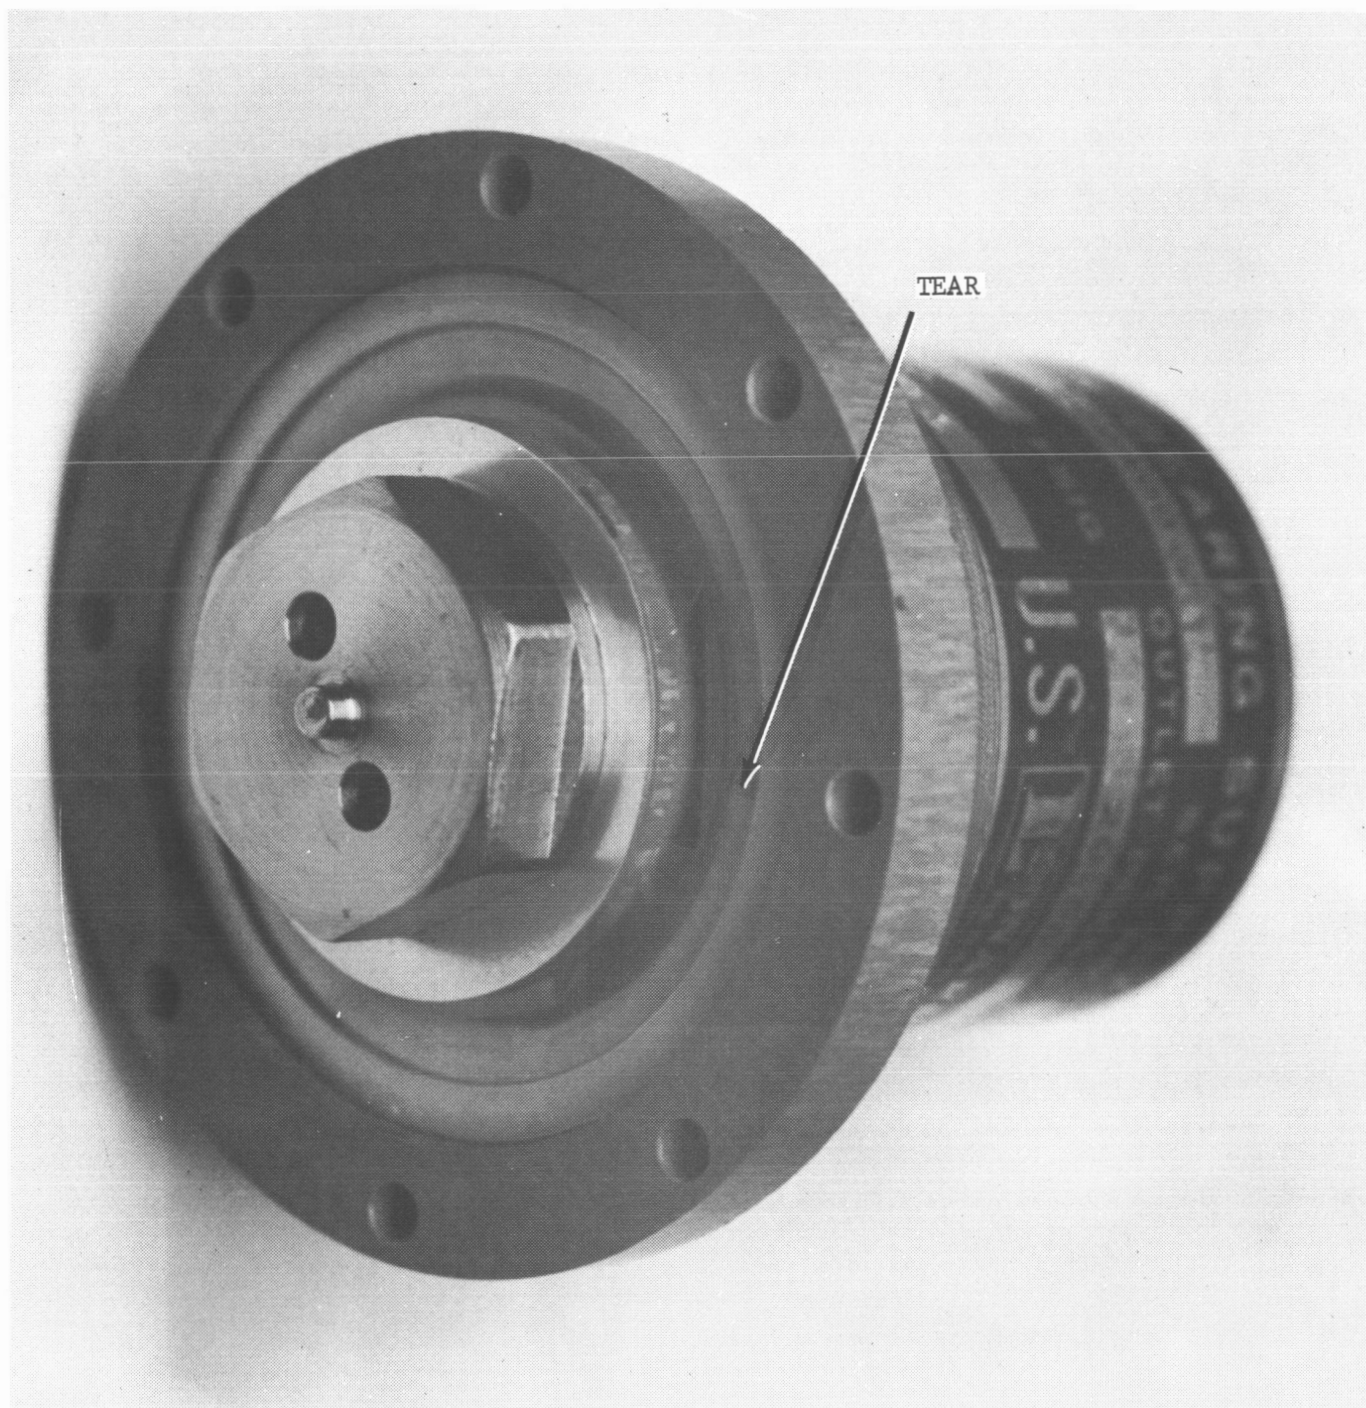
A failed diaphragm in the first stage end of the regulator is shown in Figures 7, 8, and 9. The diaphragm burst due to the sharp edge on the diaphragm

FIGURE 7. REGULATOR - FIRST STAGE PORTION - BROKEN SEAL

retainer and wrinkles in the diaphragm itself. This problem was corrected by removing the sharp edge on the retainer and modifying the forming process of the diaphragm to eliminate the wrinkles.

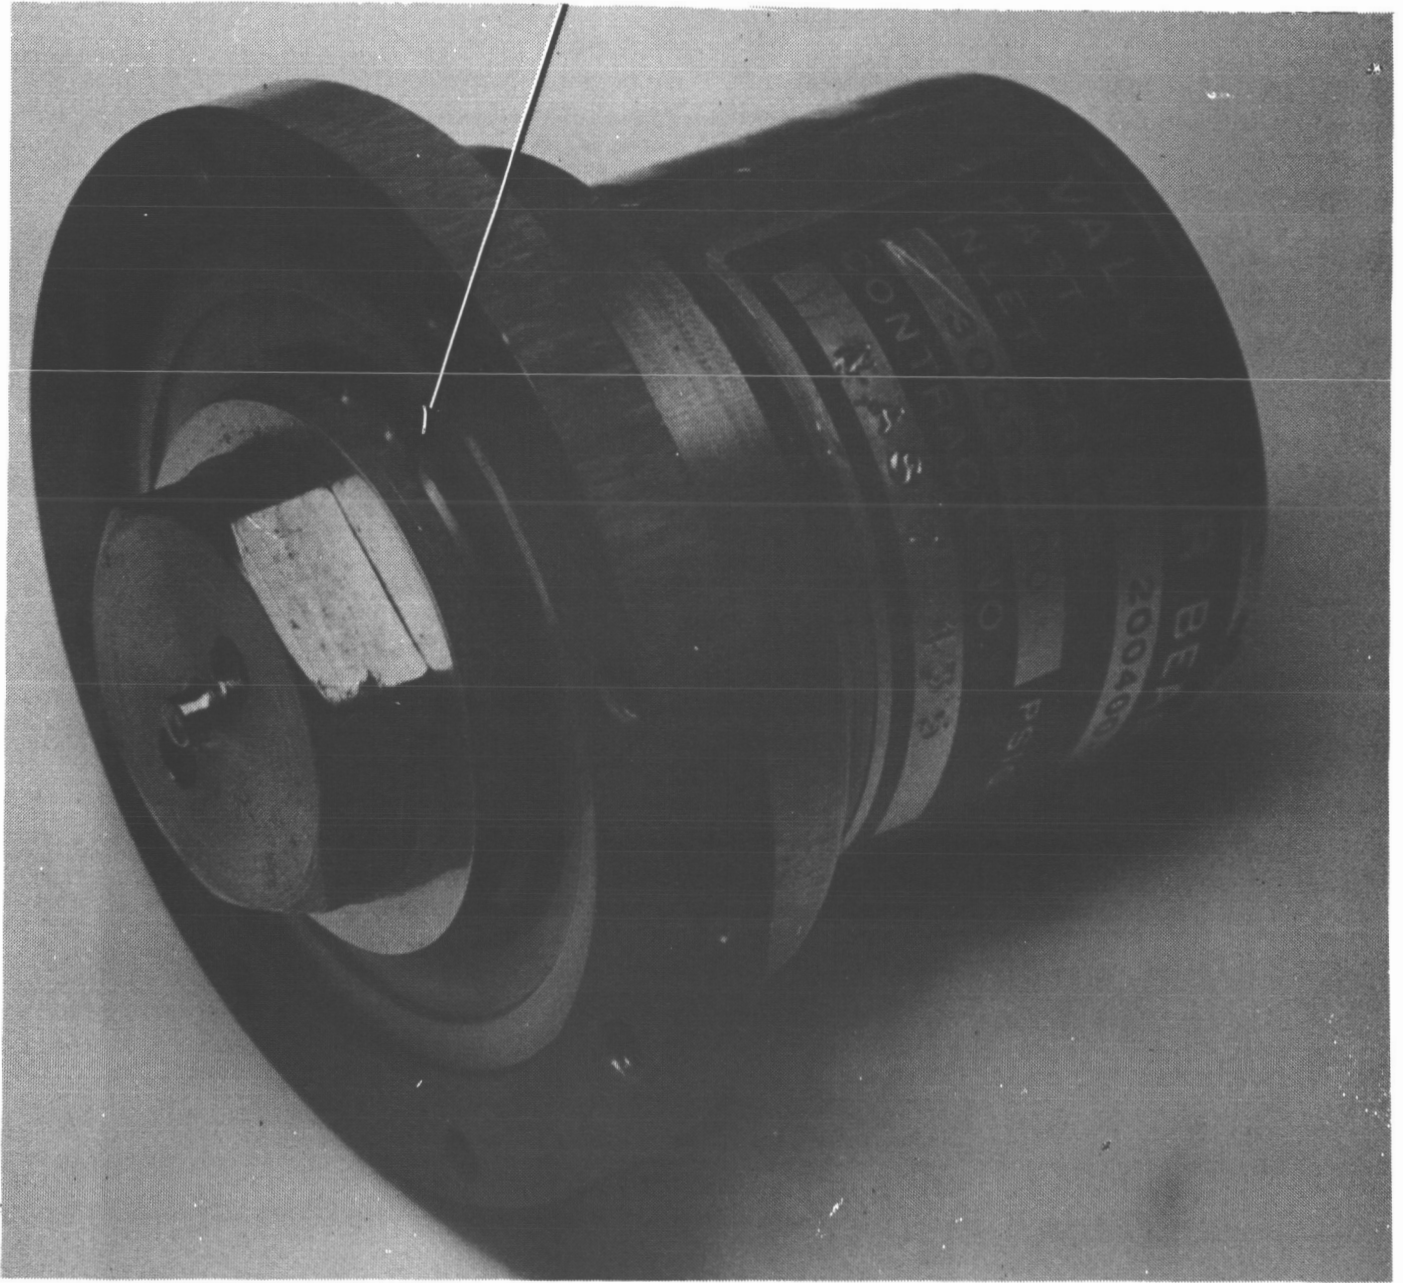
FIGURE 8. REGULATOR - FIRST STAGE PORTION - WRINKLED SEAL

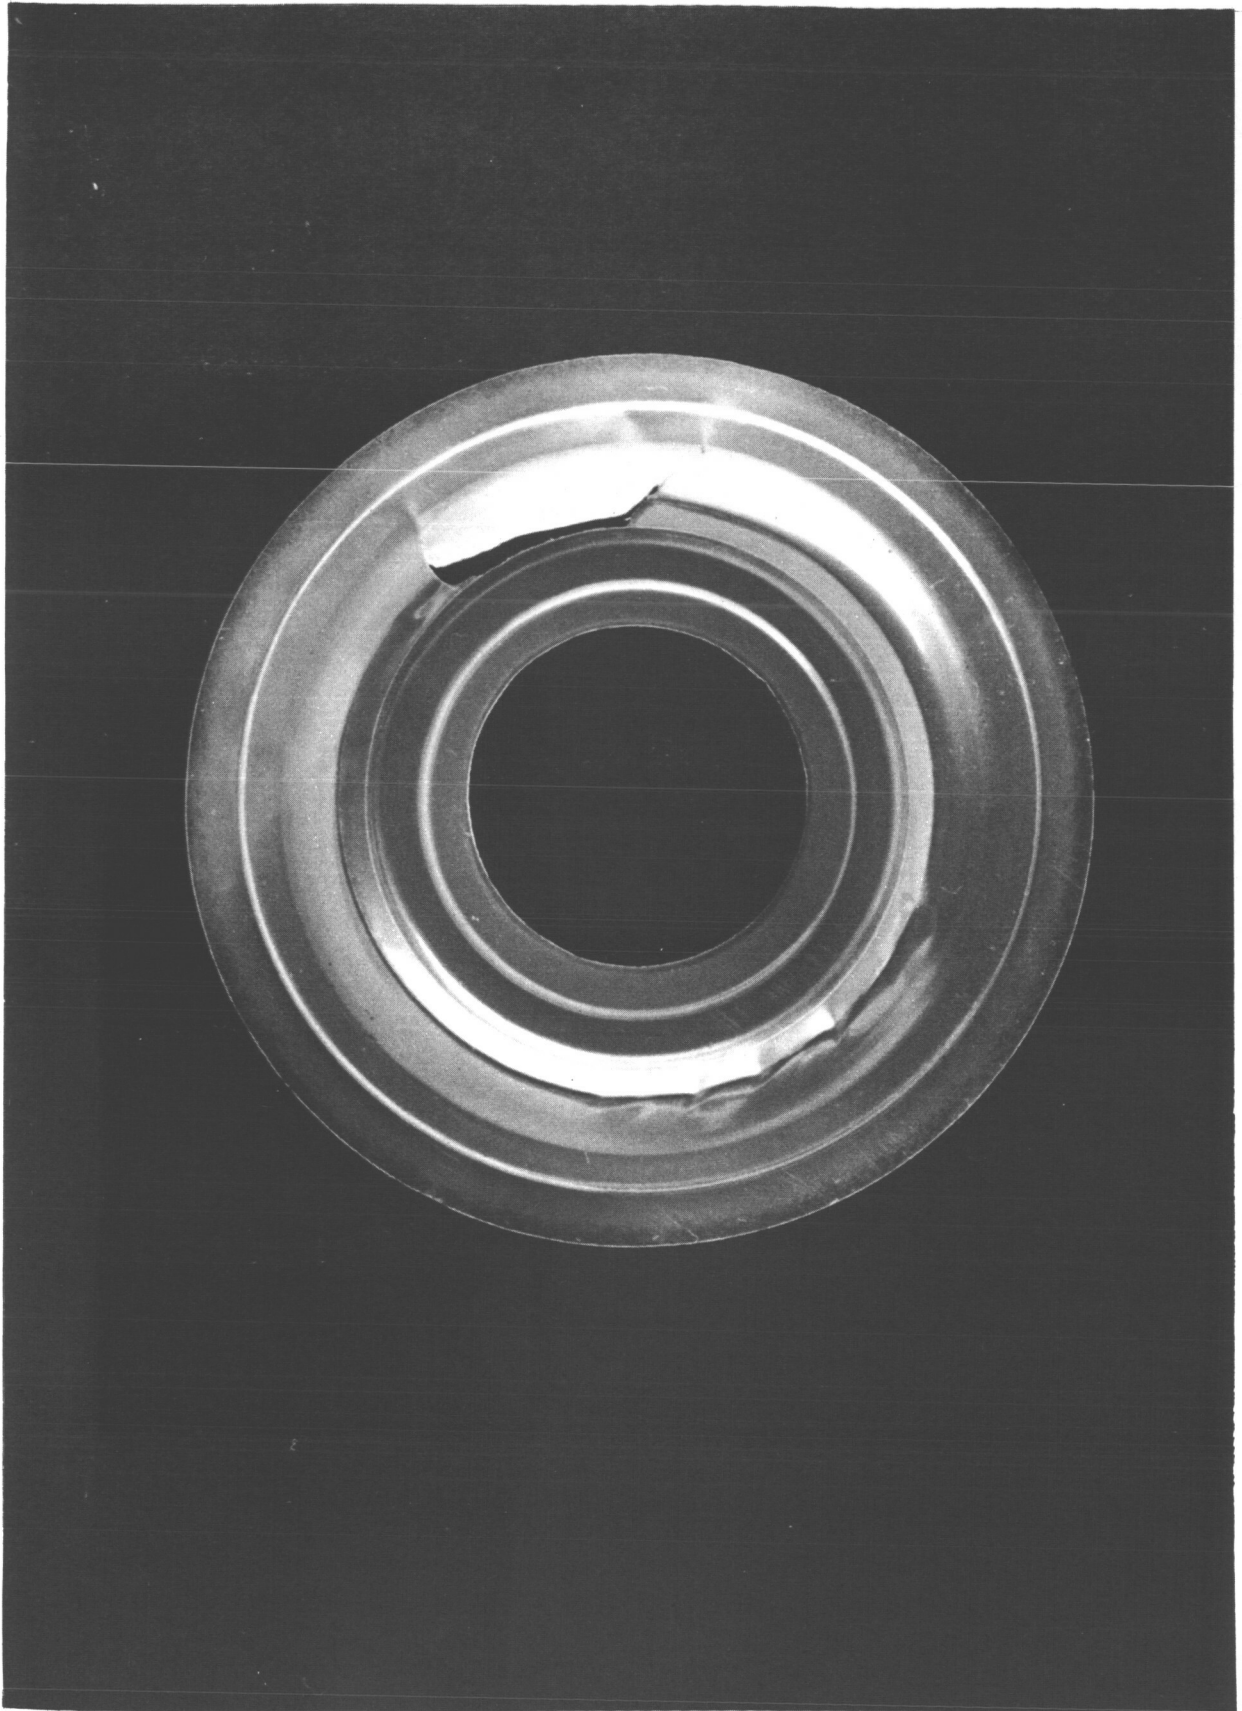
FIGURE 9. DAMAGED REGULATION SEAL

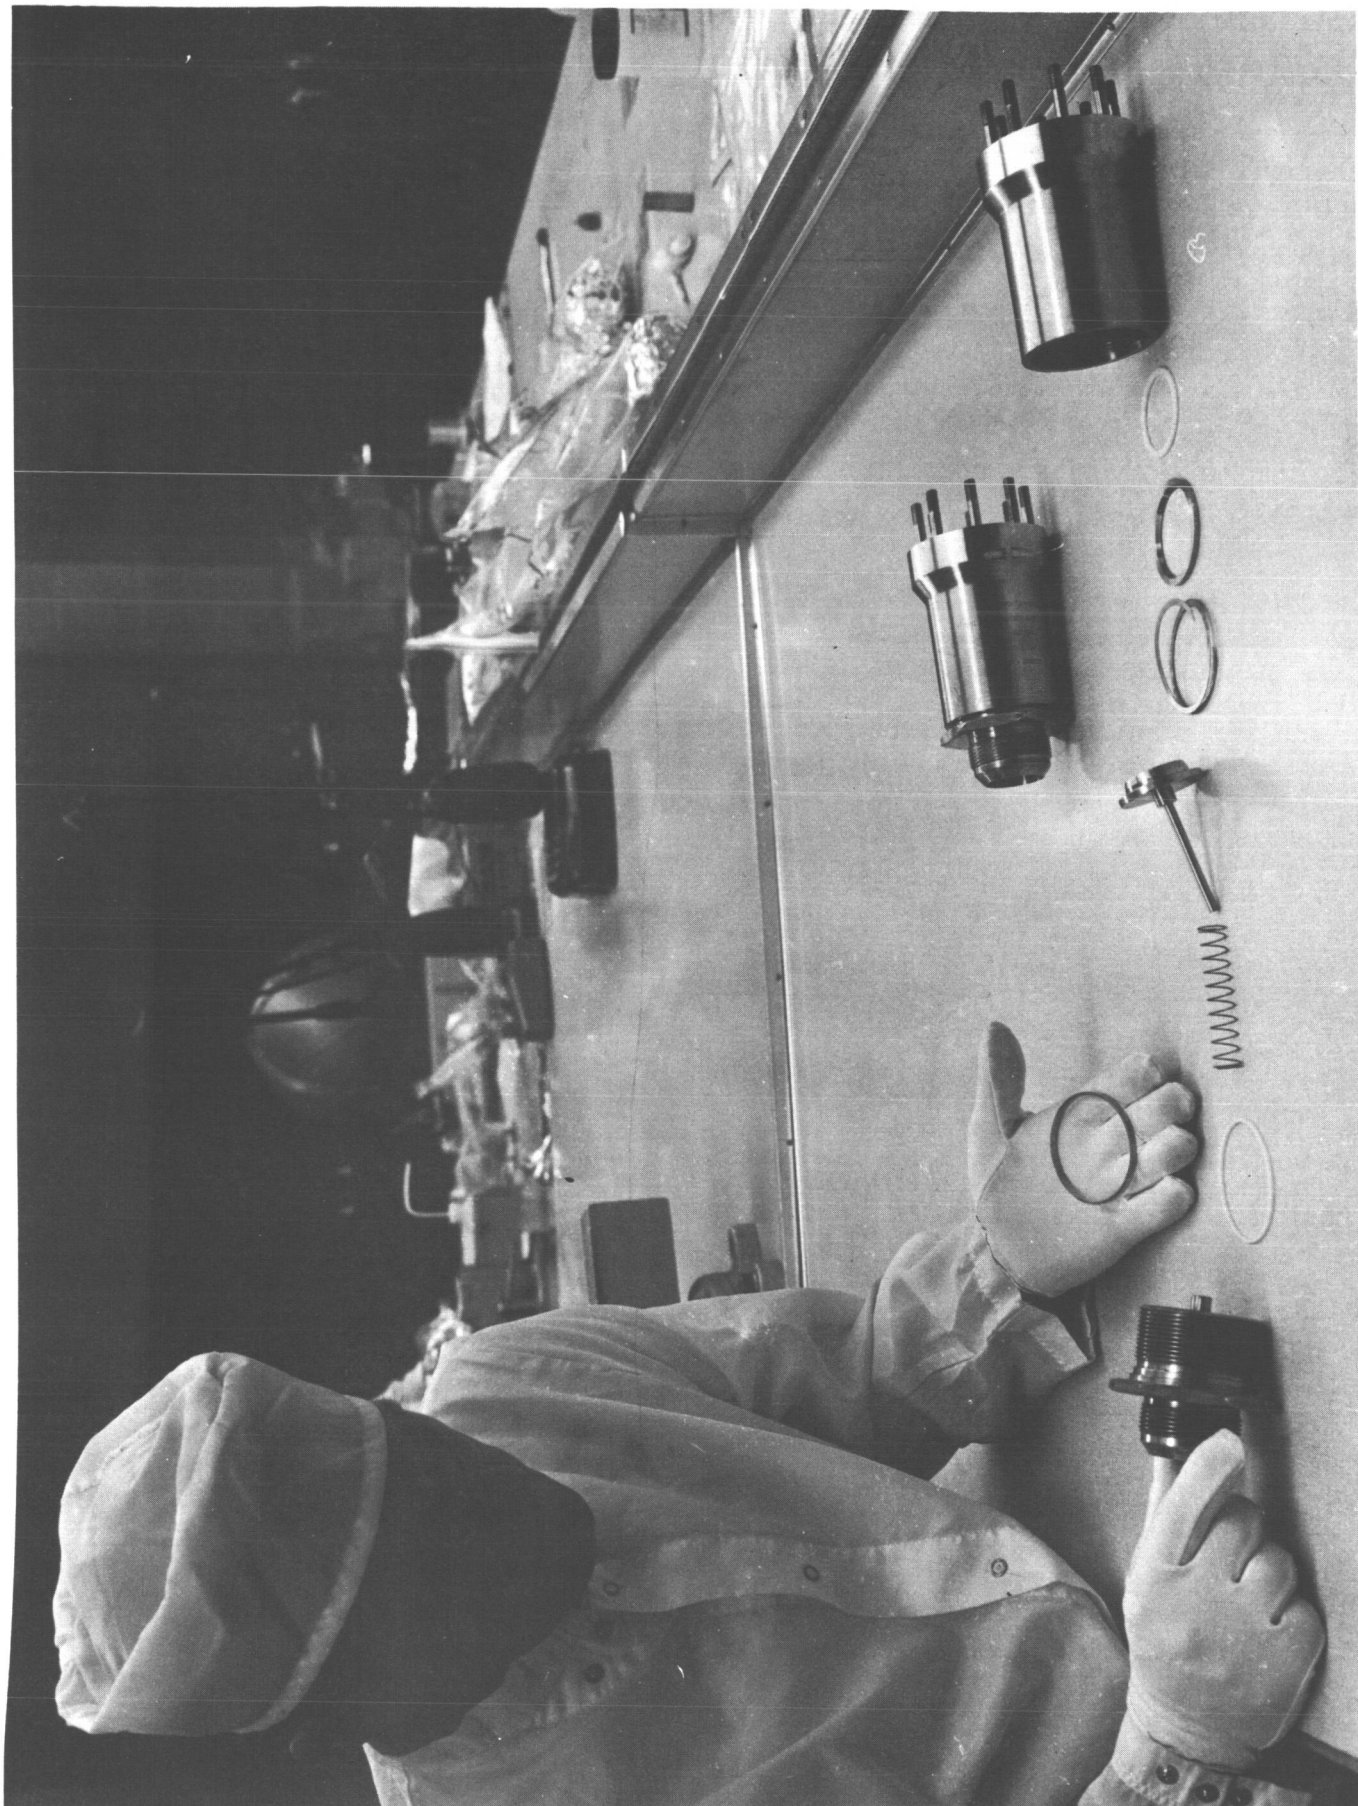
A problem was also encountered with the LOX Heat Exchanger Check Valve. The LOX containers on the Saturn Vehicle are pressurized during flight by LOX which has passed through the rocket engine heat exchangers. Within this pressurizing system, check valves are located between the heat exchangers and the LOX containers. On the Block I Saturn vehicles no major problems with these check valves were encountered, but on the Block II Saturn the check valves were exposed to a higher temperature which caused external leaking during the static firing of SA-5. This increased heat caused the Teflon seal between the valve body halves to flow out of shape causing the valve to leak (Figure 10). This problem was corrected by changing the material of the housing seal from Teflon to copper (Figure 11).

FIGURE 11. REPLACING OF TEFLON SEAL WITH COPPER SEAL

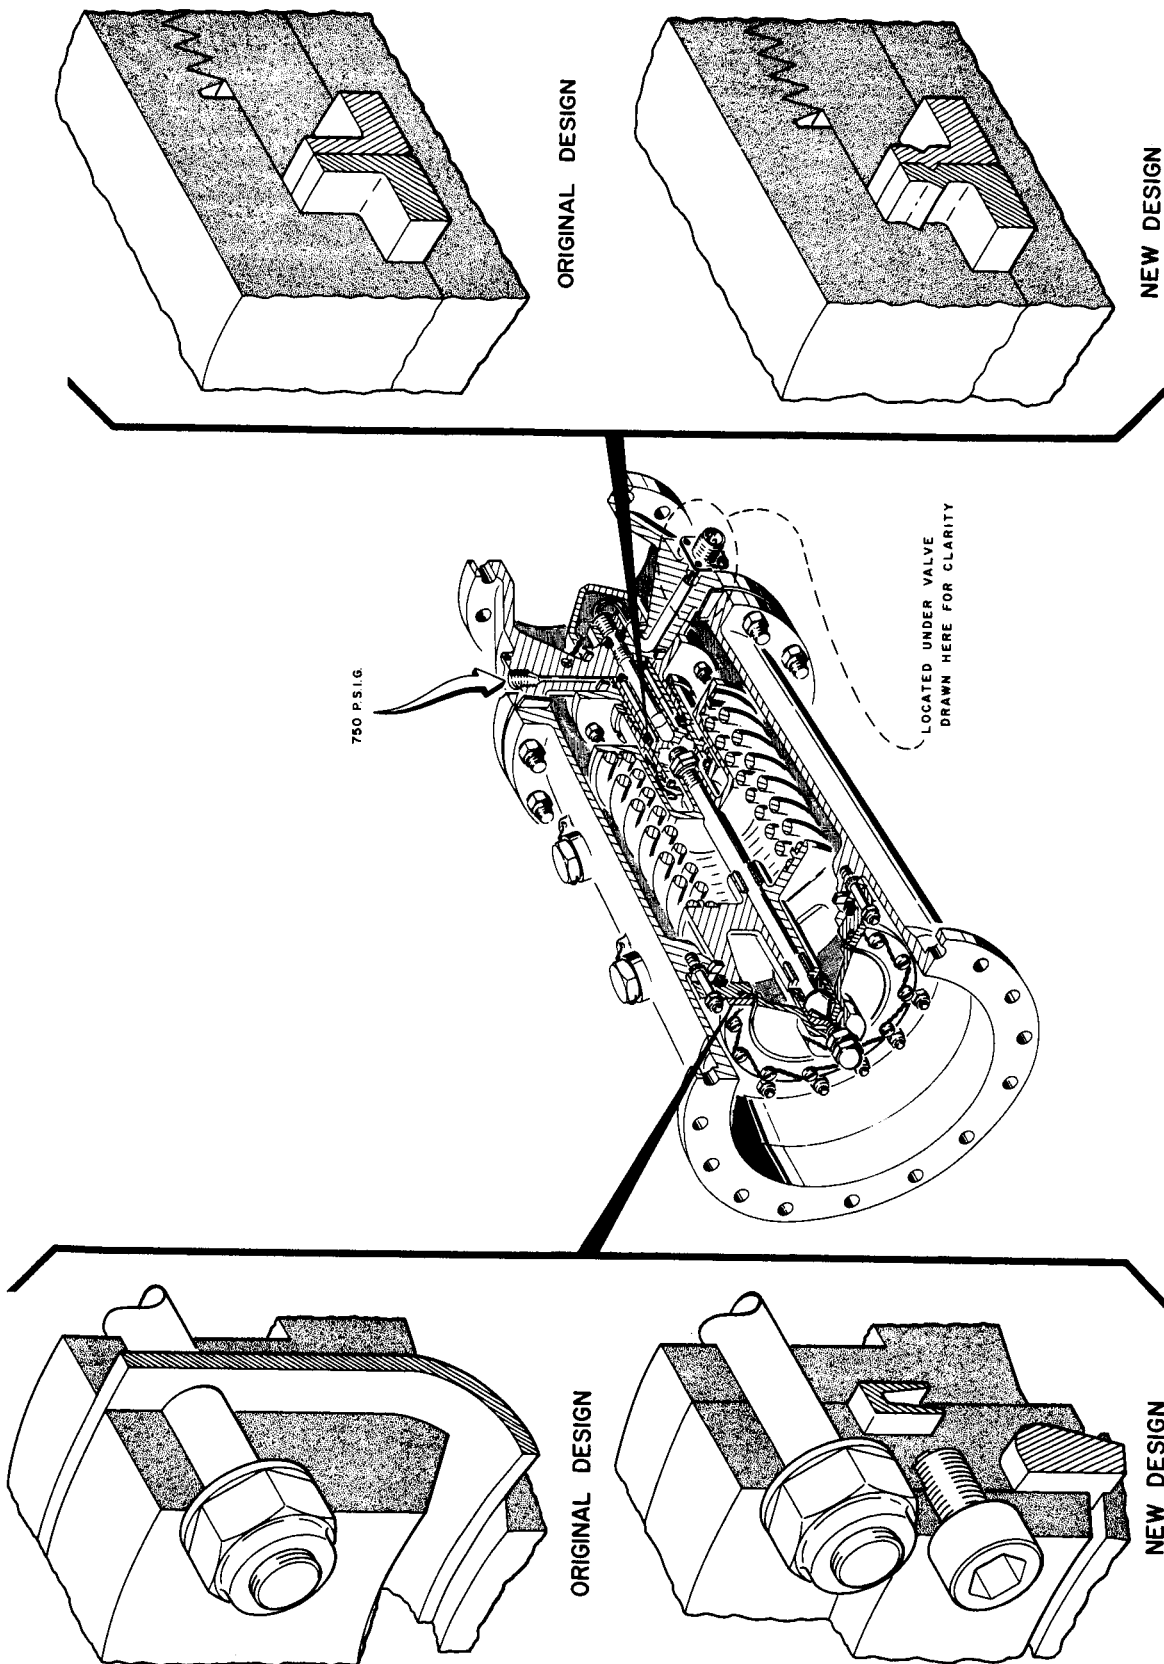
One problem involved the fact that the valve would not maintain the relief setting, which caused excessive leakage through the main seat (Figure 13). This seat consisted of a tapered rigid poppet seating inside a lip seal. This situation was corrected by replacing the lip seal with a solid Kel-F seal machined on the I.D. to fit the taper of the poppet and redesigning the poppet so that it would swivel for alignment purposes.

FIGURE 13. LOX RELIEF VALVE DESIGN CHANGES

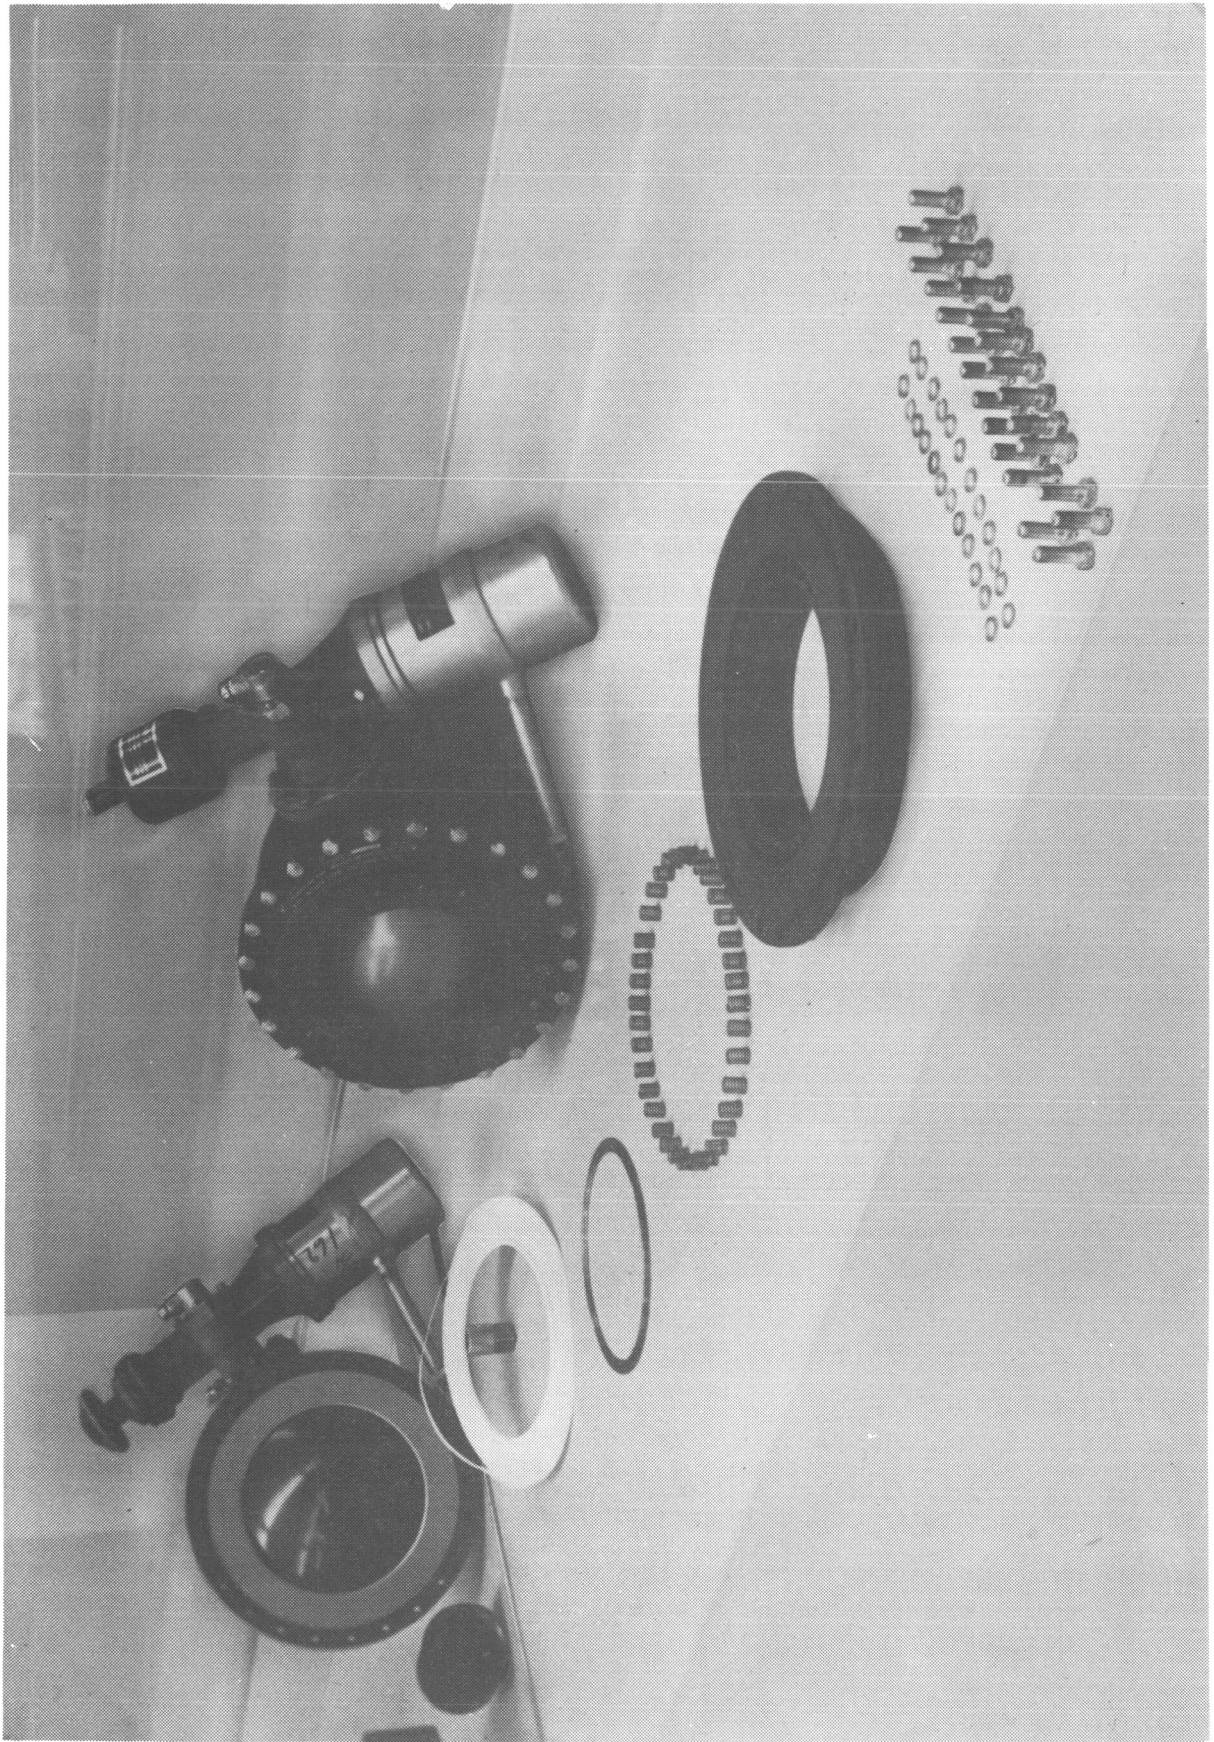
One problem with this valve occurred when the main seal leaked LOX during the static firing of SA-5. The cause of this failure was found to be a split in the outer portion of the main seal (Figure 15). The cause of the split was found to be the serrated design of the flange which secures the O.D. of the main seal. These male serrations would cut into the seal to prevent leakage. Because the main seal is made of Teflon, which has a tendency to flow under pressure, the male serrations cut sufficiently into the seal so that the pressure imposed on the valve during static tests caused the seal to split. The solution to this problem was to reverse the serrations. The male serrations were removed and female serrations machined into the flange (Figure 16).

FIGURE 15. CONTAINER FILL AND DRAIN VALVE WITH DAMAGED SEAL

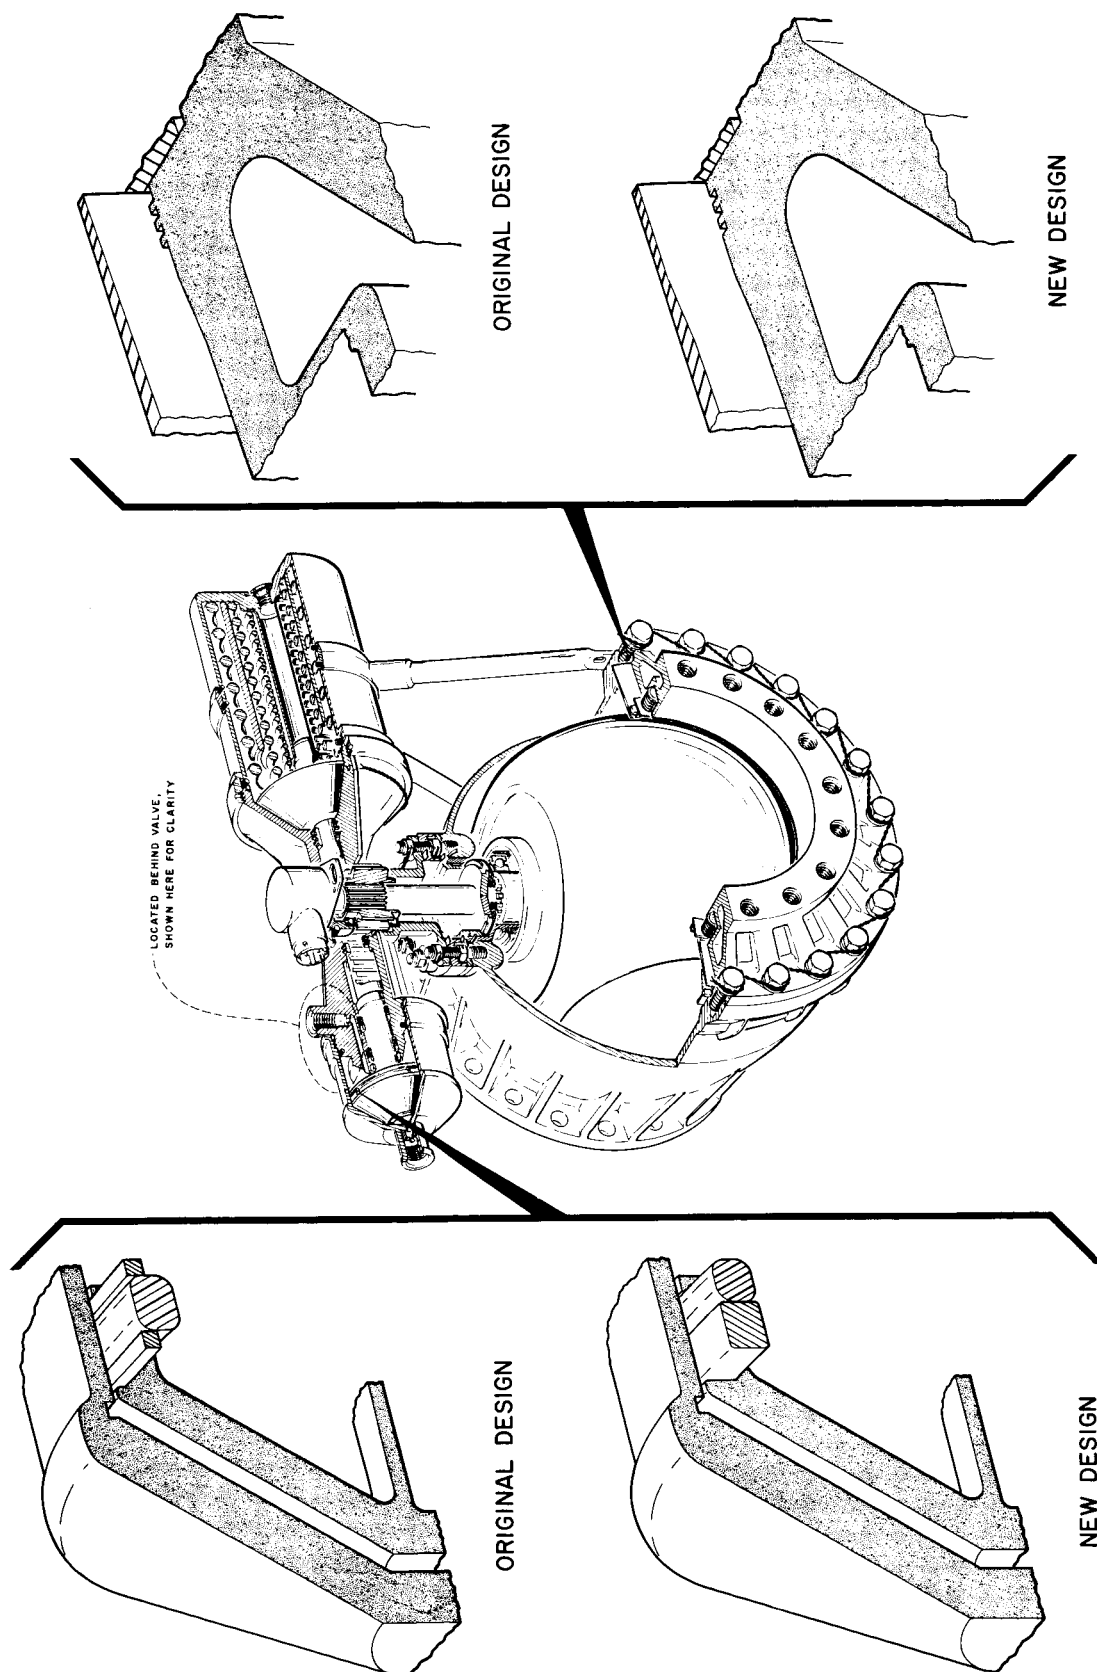
Another problem was encountered when the control system leaked excessively past the piston O-ring. This was caused by the O-ring groove design in the piston (Figure 16). The old design consisted of a small Teflon bearing located on each side of the O-ring. During operation of the valve the Teflon bearings would twist, causing the O-ring to leak. This problem was corrected by modifying the O-ring installation so that the O-ring had only one large Teflon bearing (Figure 16).

FIGURE 16. LOX FILL AND DRAIN VALVE DESIGN CHANGES

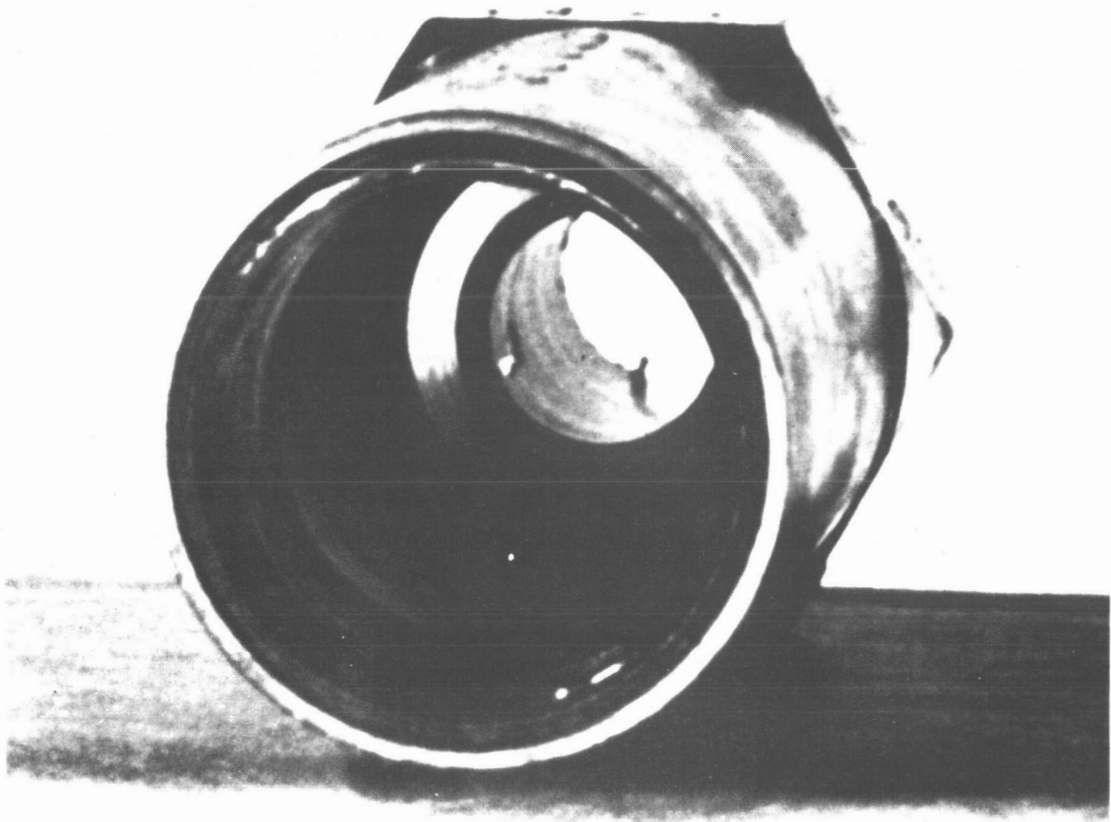
Figure 17 shows the cause of a leaky check valve. A metallic chip was lodged on the main seat.

FIGURE 17. CHECK VALVE WITH METALLIC CHIP

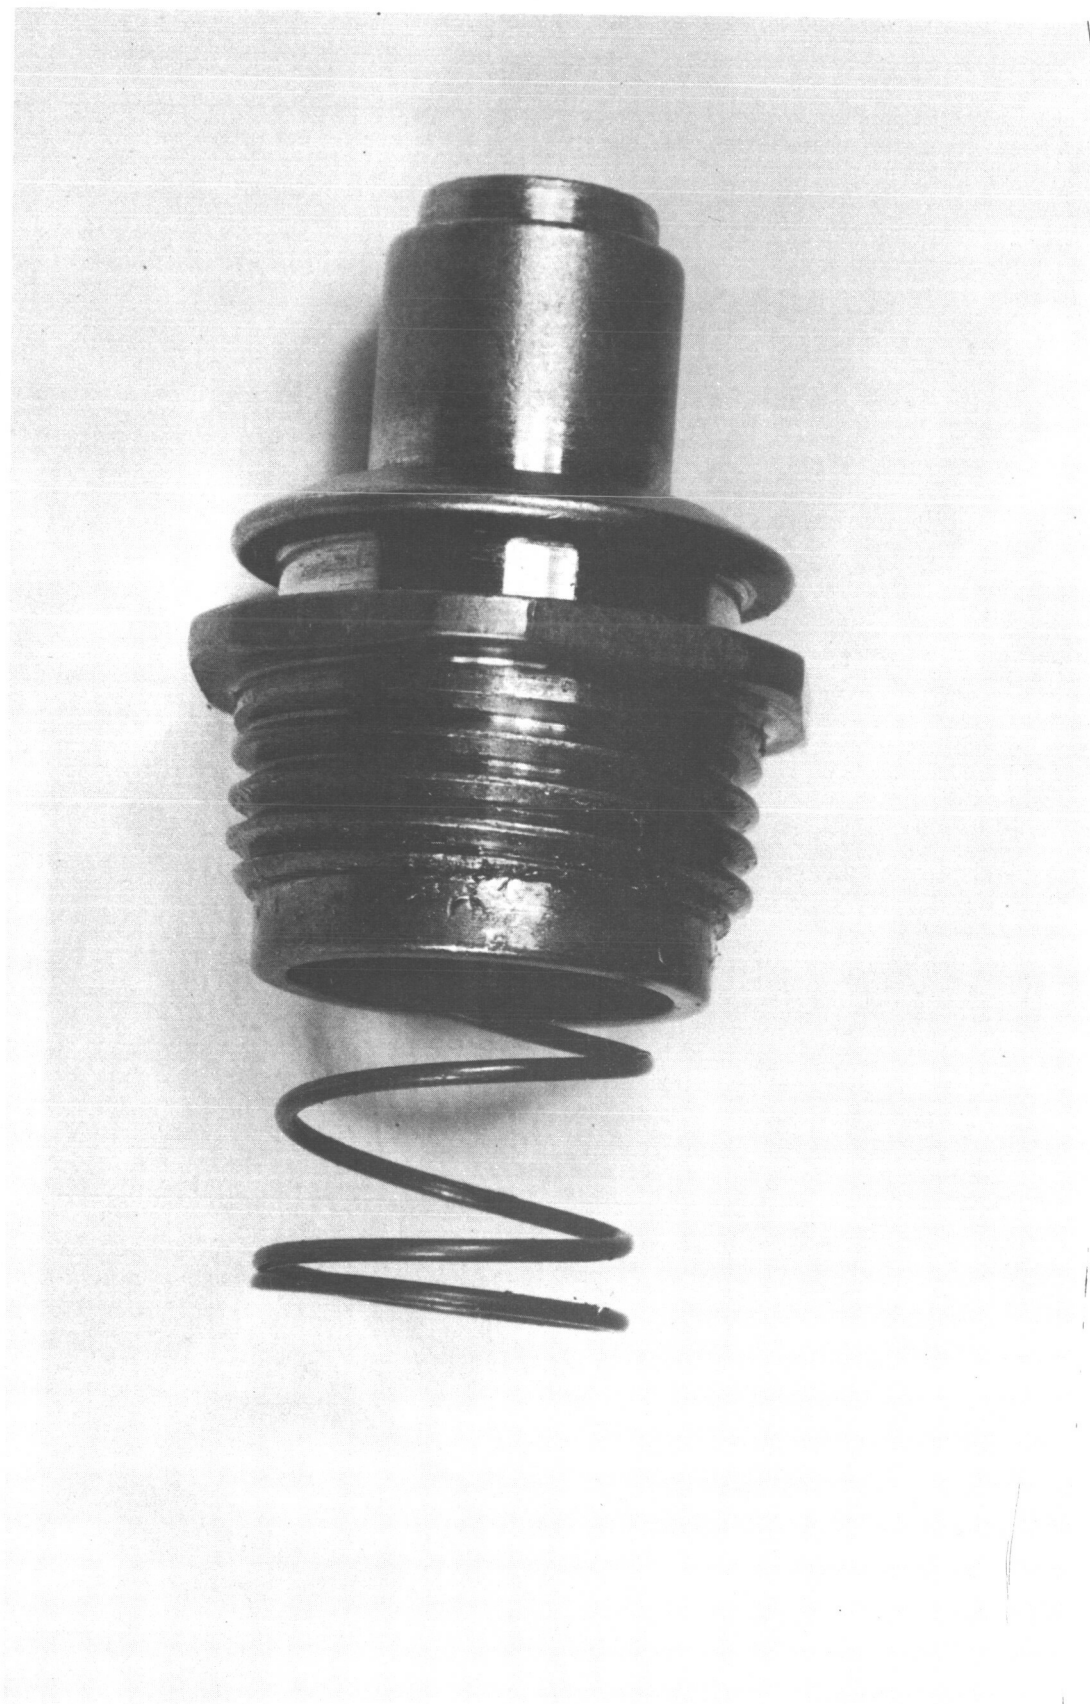
Figures 18 and 19 show a contamination problem caused by metallic chips. The chips were caused by the bad installation of the self locking thread device. The self-locking device consisted of a small nylon plug inserted in a hole drilled in the threads of the male fitting (Figure 18). It was found that the

FIGURE 18. METAL CHIP CONTAMINATION ON EXTERNAL THREADS

drilling operation for the hole had left a distorted sharp edge on the threads. Since the male fitting was made of stainless steel and the female fitting was made of aluminum, the metallic chips were cut from the female fitting threads as the two fittings were joined.

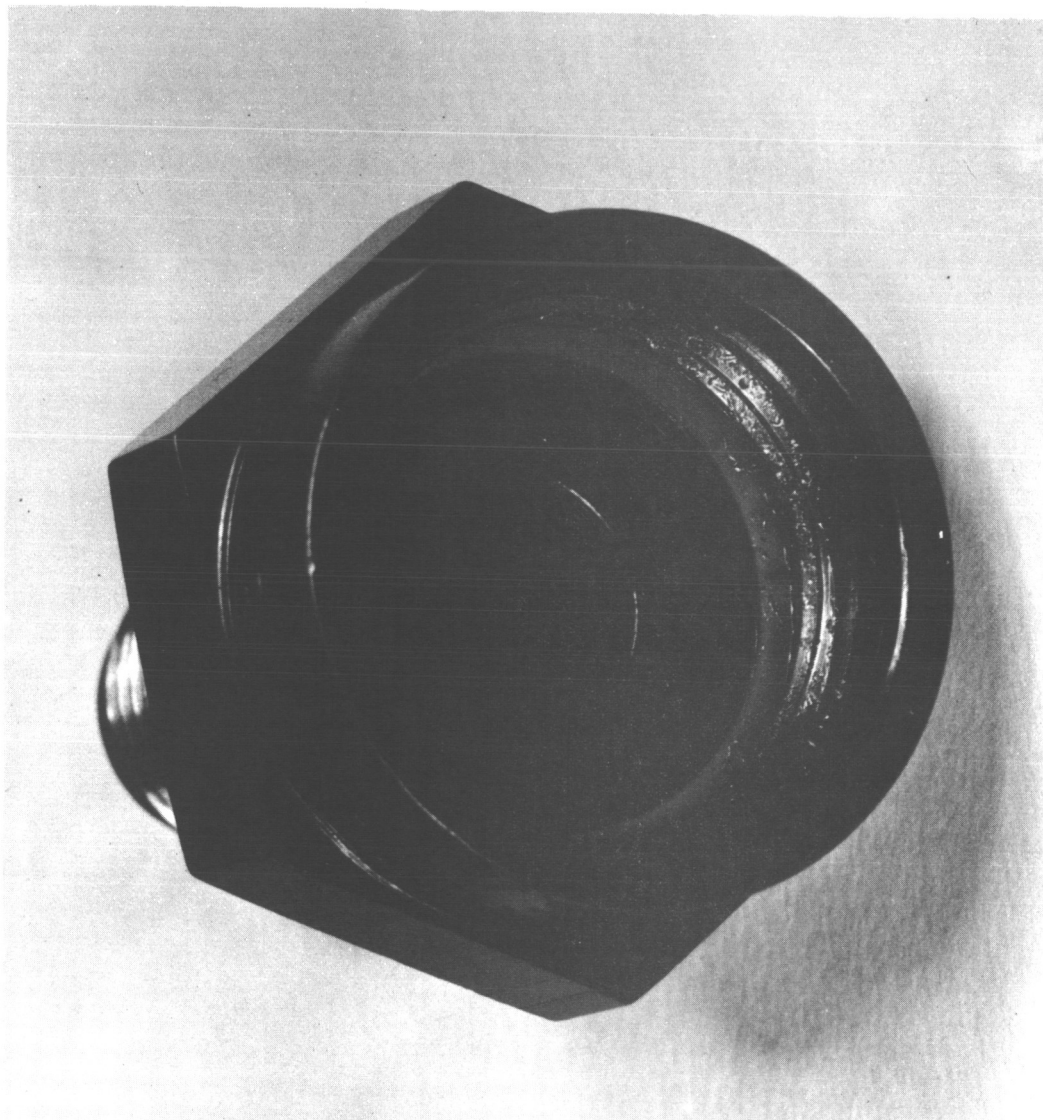
FIGURE 19. METAL CHIP CONTAMINATION ON INTERNAL THREADS

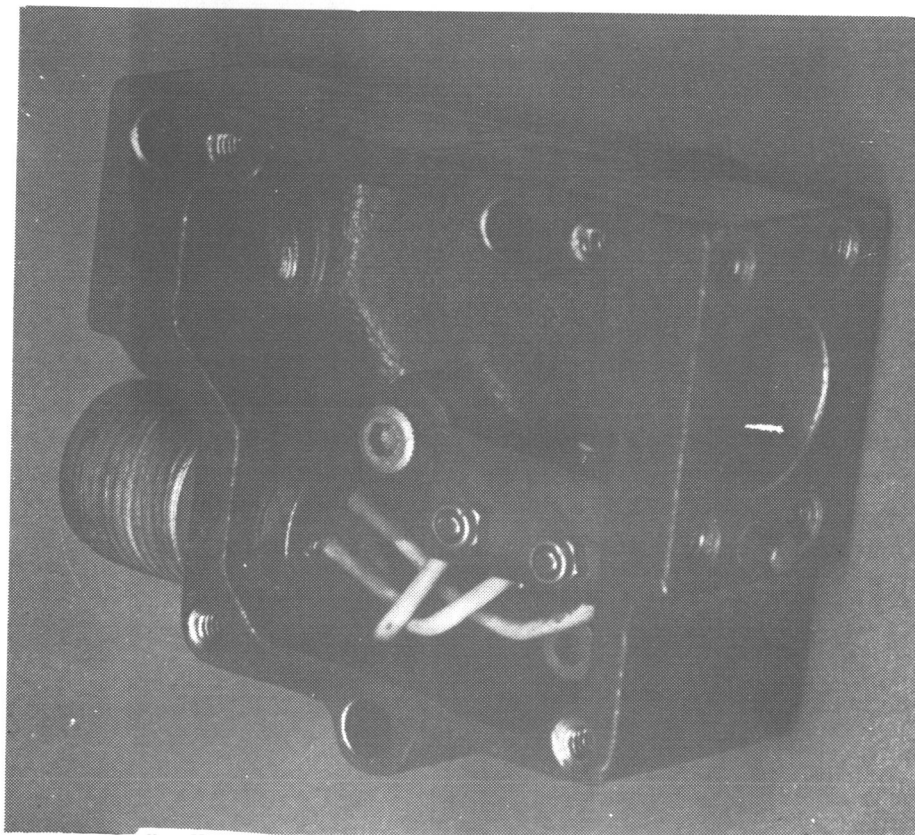
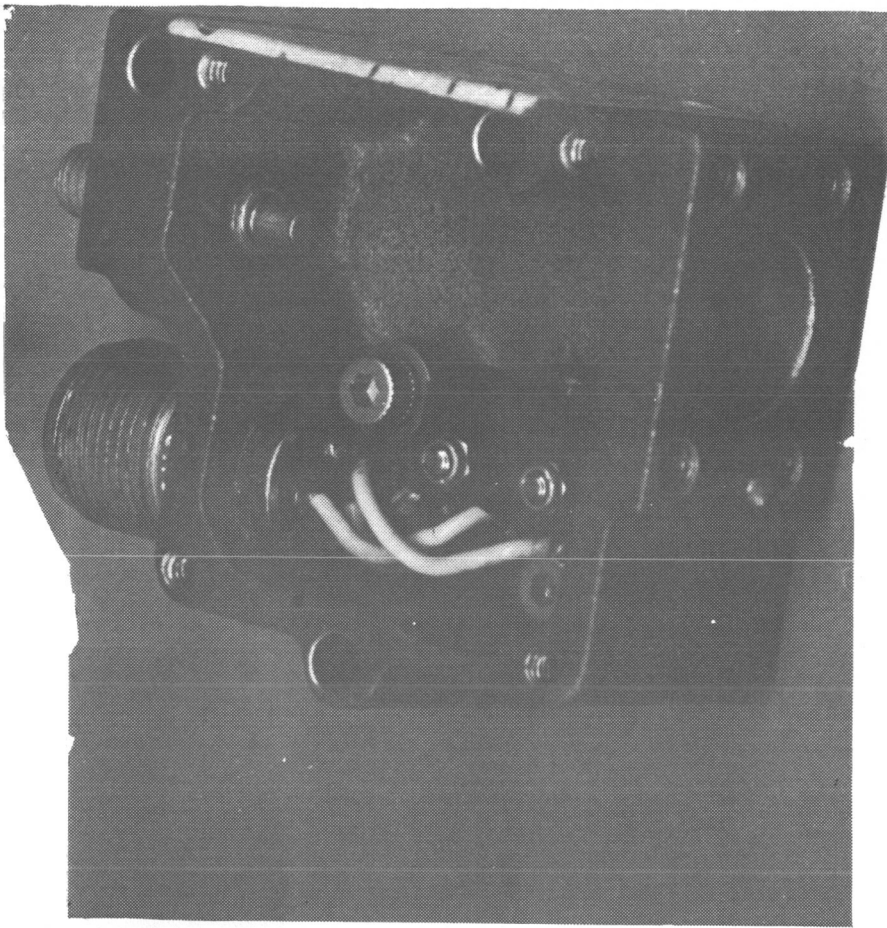
Figures 20 and 21 show the poor quality of two different type pressure switches that had failed on two of the Saturn Vehicles during checkout.

FIGURE 20. PRESSURE SWITCH MACHINING VARIATION REQUIRING REWORK OF SPRING SEAT
